**PROJECT MEMORANDUM**  
**SCE WEST OF DEVERS UPGRADE PROJECT**

**To:** John Forsythe, Project Manager, CPUC  
**From:** Vida Strong, Aspen Project Manager  
**Date:** September 6, 2019  
**Subject:** Monitoring Report #78: August 25 to August 31, 2019

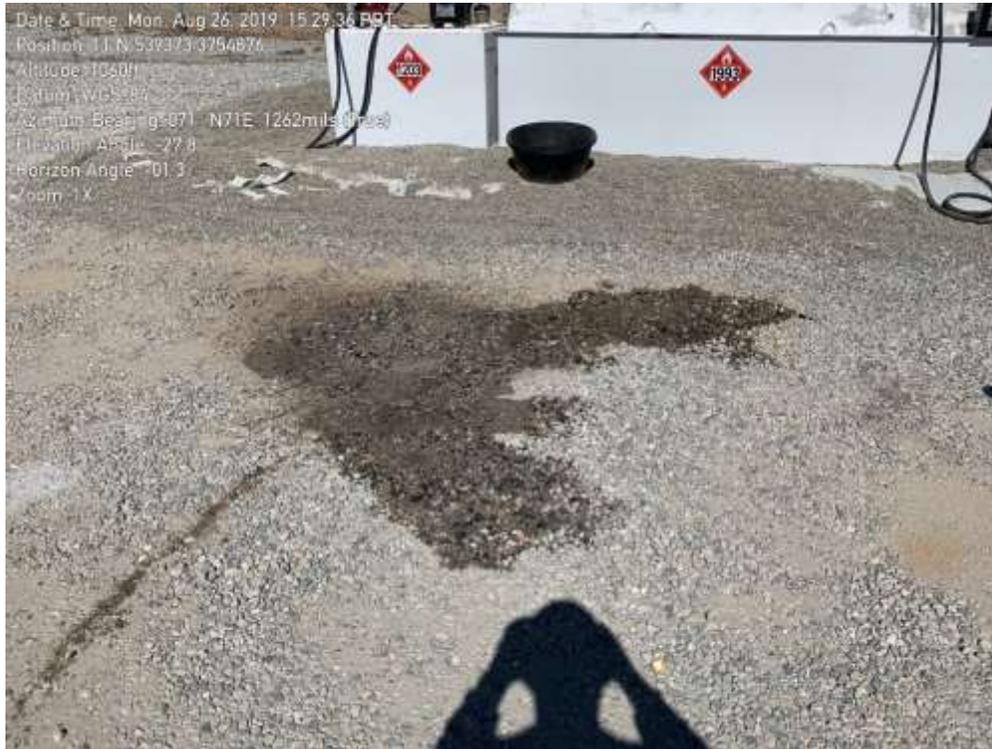
1. There were no SCE self-reported or CPUC incidents documented for construction activities associated with NTP #1 throughout the monitoring period.
2. There were no SWPPP maintenance items or corrective actions associated with NTP #1 recorded during the monitoring period. To date, there are no open SWPPP maintenance or corrective actions associated with NTP #1.
3. There was one SWPPP maintenance item documenting the clean-up of a diesel spill at the Devers MY during the monitoring period. To date, there are no open SWPPP maintenance items or corrective actions associated with NTP #1.
4. There was one reportable (> 1 gallon) and no non-reportable (< 1 gallon) spills associated with NTP #1 identified during the monitoring period. On August 26, a loose hose fitting caused diesel fuel to be spilled on the ground around the fuel storage tank at the Devers MY (see Photo 1). The impacted

materials were placed into a 55-gallon drum and were hauled to the Poultry MY for disposal at an SCE approved waste facility.

Photo 1 – Diesel spill at the Devers MY was reported on August 26. (Photo courtesy of SCE).

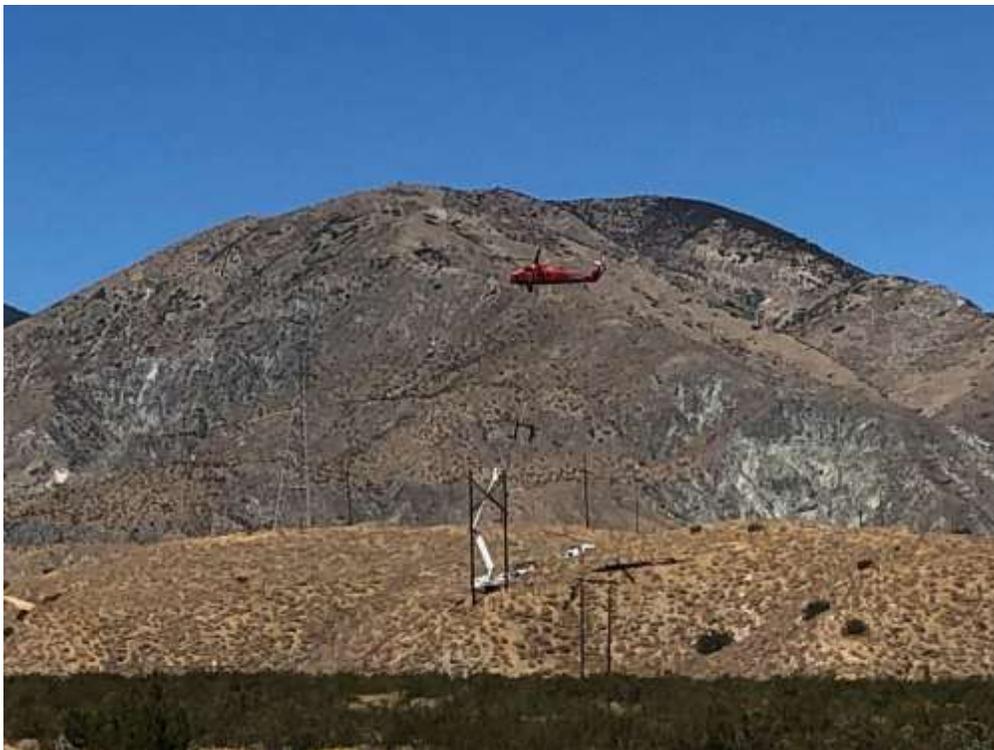
7. Work associated with Segment 6 (non-BLM lands) included: Wire and structure wreck-out between Construction Areas T249 and T227 (6N35-6X41) (see Photo 2); foundation activities at Construction Areas 6S29, and 6X30; BMP maintenance and installation at Construction Areas 6S25, WSS-6S26-6S27, 6S26, and WSS-6S26-1-MPR-29; tower assembly at Construction Areas 6X24, and 6S28 (see Photo 3); and tower wreck-out at Construction Areas WSS-6-6S34-1-MPR-29, T238, and 6S34.

Photo 2 – Wreck-out of existing wood poles on Segment 6 using a helicopter due to accessibility constraints (August 29, 2019).

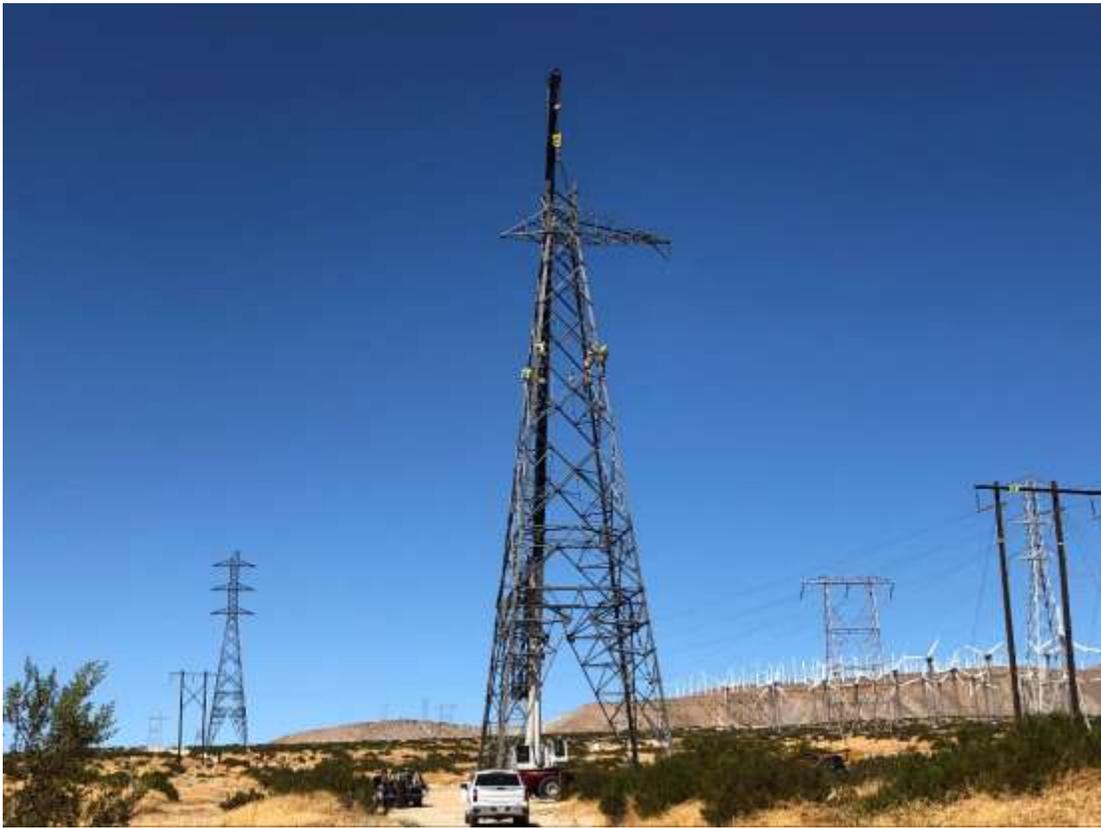
Photo 3 – Tower assembly at Construction Area 6X24 on Segment 6 (August 29, 2019).
